## Local Notice to Mariners

Number 04 of 2026

### **Port of Southampton – Pilot Boarding and Disembarking Arrangements – Non-compliant, Counterfeit, or Defective Pilot Ladders**

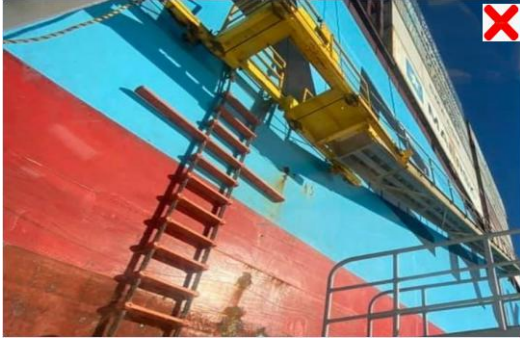
**Figure 1 - Non-Compliant Trap Door Arrangement**

The arrangements in Figure 1 and Figure 2 (below) are non-compliant because:

1. The pilot ladder is not rigged to extend through the trapdoor and secured 1½ metres above the bottom platform (SOLAS 3.3.2.1). The method of securing the ladder to the underside of the platform shown in the figure is dangerous because the transition from the pilot ladder is done via an uneven step height.
2. The horizontal cross member to which the pilot ladder is secured is a distraction from using the side ropes when transitioning onto the pilot ladder when disembarking.
3. The pilot ladder steps cannot rest firmly against the ship's side, due to the nylon wheels attached on the inboard side of the bottom platform.
4. The 'accommodation ladder' is not securely attached to the hull.

**NOTICE IS HEREBY GIVEN** that some ships have presented with a pilot transfer arrangement consisting of an accommodation ladder / pilot ladder combination with a trapdoor that does not meet IMO standards (which have been in effect since at least 2012). Southampton Pilots have been reminded that they must refuse to use a pilot transfer arrangement that they reasonably believe is unsafe. Any vessels with a trapdoor arrangement are urged to bring their arrangements into compliance with the current IMO standards as soon as possible in order to avoid potential disruptions to ship schedules and port operations.

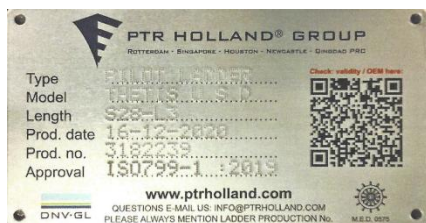
It has recently come to the attention of ABP Southampton that some vessels are in possession of counterfeit pilot ladders that are not compliant with ISO standards. The current legislation is that pilot ladders MUST comply to **ISO799-1**, and their certificate and certification plate must display this.

Counterfeit ladders displaying compliance to **ISO779-1** have been identified. These are non-compliant and will be refused by ABP Southampton Pilots.

Figure 4 shows a non-compliant certification plate because it references approval **ISO779-1**.

Figure 5 shows a compliant certification plate because it is referencing approval **ISO799-1**.

Where non-compliant ladders are discovered, this will be reported to Port State Control and further inspections may be carried out.
